| | [REDACTED]<br>Rogers, [REDACTED]<br>[REDACTED] | Daily Structural Steel<br>Inspection Report | NSTC.NDT.VTP.01.F1 | |

| Project Name | [REDACTED] | Inspector | Jeremy [REDACTED] | | |

| Structural Steel: Anchor Bolting, Level 02 Framing and Brace Frames |

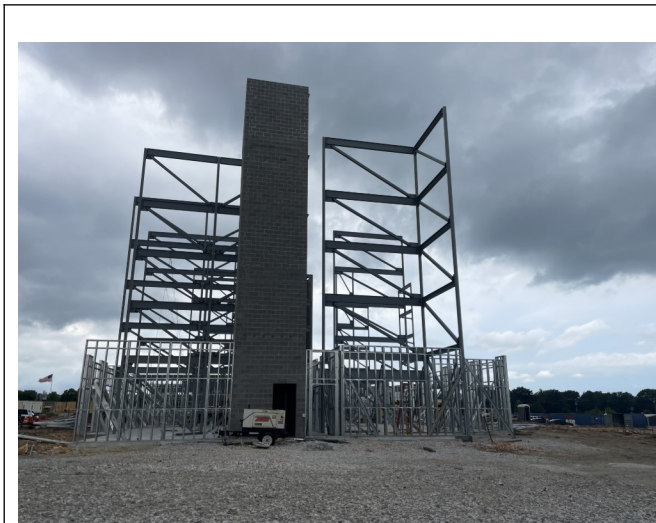
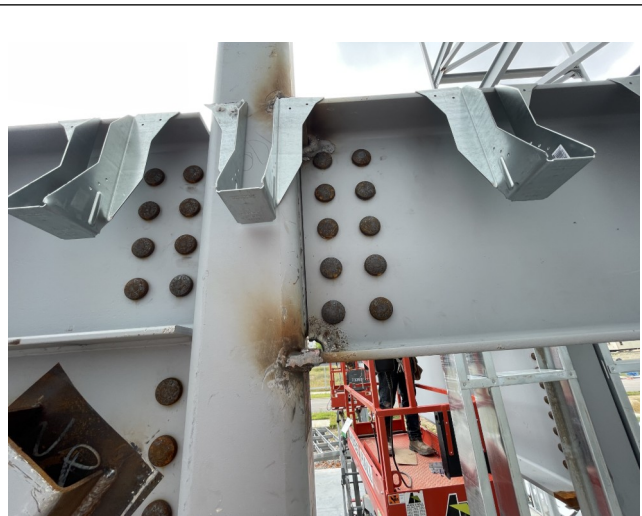
Moment connections at (4.7/E) and (4/H.8) were repaired and appeared visually acceptable; however, the remaining discrepancies listed below were observed. Several of these connections contained previously documented discrepancies, including gapped backing bars. The repair process was not observed, and adequate root weld penetration could not be verified.

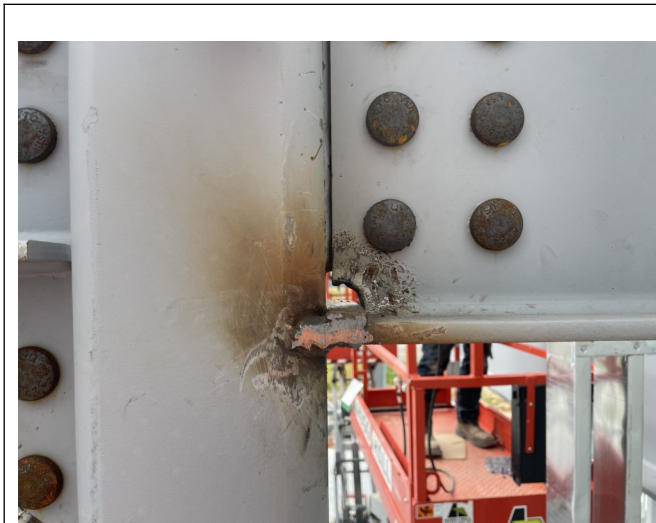
Moment connections at (4.7/E) and (4/H.8) were repaired and appeared visually acceptable; however, the remaining discrepancies listed below were observed. Several of these connections contained previously documented discrepancies, including gapped backing bars. The repair process was not observed, and adequate root weld penetration could not be verified.

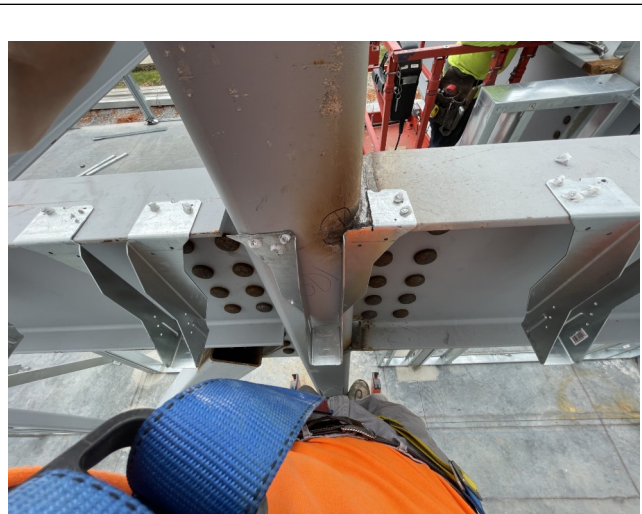
Moment connections at (4.7/E) and (4/H.8) were repaired and appeared visually acceptable; however, the remaining discrepancies listed below were observed. Several of these connections contained previously documented discrepancies, including gapped backing bars. The repair process was not observed, and adequate root weld penetration could not be verified.

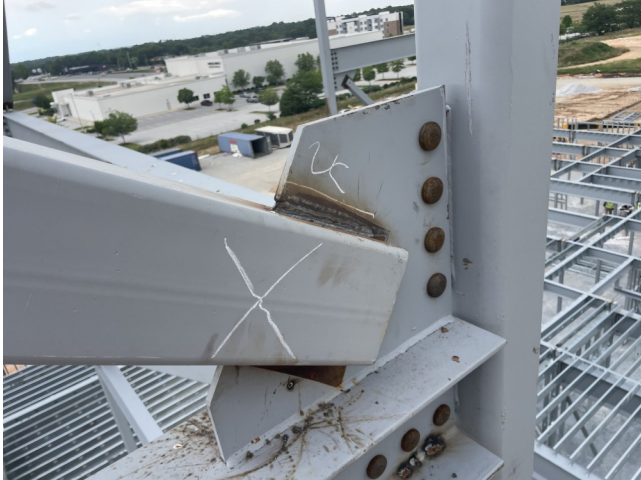
2. Field welding on Brace Frames 01 through 13, Sheet S13, was visually inspected following completion of welding.

Welding repairs at Brace Frame 01 on grid line 01 and Brace Frame 02 on grid line 22 appeared visually acceptable per the drawings and specifications. **Note:** Visual inspection of all below-grade brace frame connections could not be performed due to concrete placement.

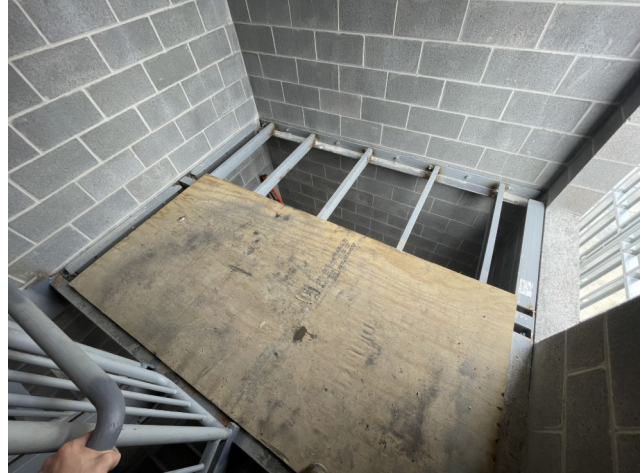
Welding on the stair case at grid lines (26 to 27; C to B.8) appeared visually acceptable except for the listed discrepancies below.

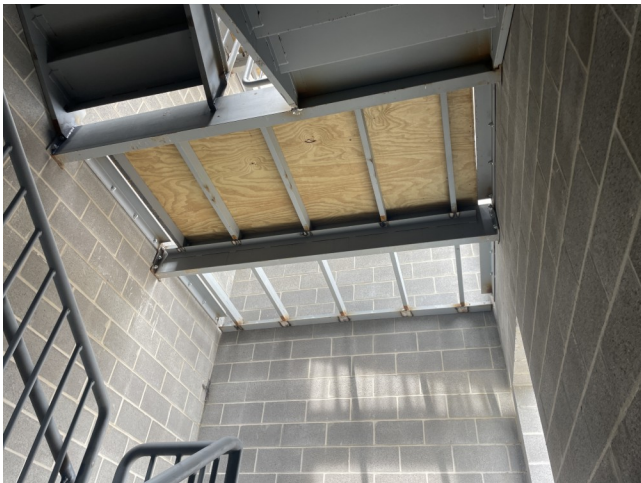
Welding on the stair case at grid lines (26 to 27; C to B.8) appeared visually acceptable except for the listed discrepancies below.

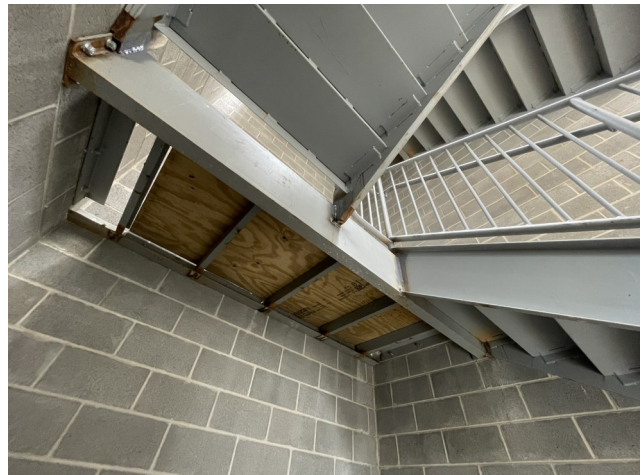
Welding on the stair case at grid lines (26 to 27; C to B.8) appeared visually acceptable except for the listed discrepancies below.

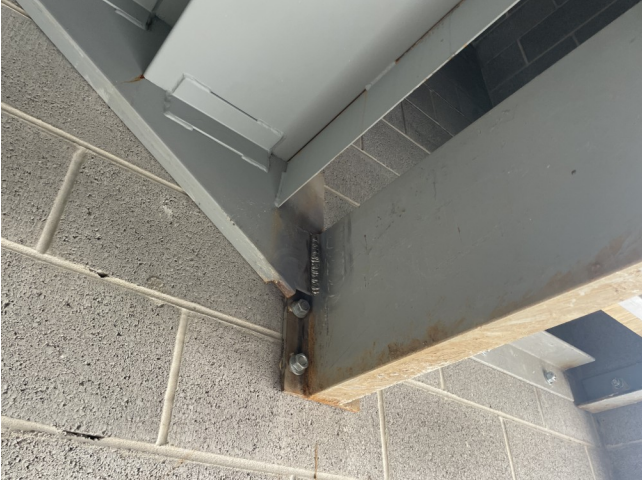
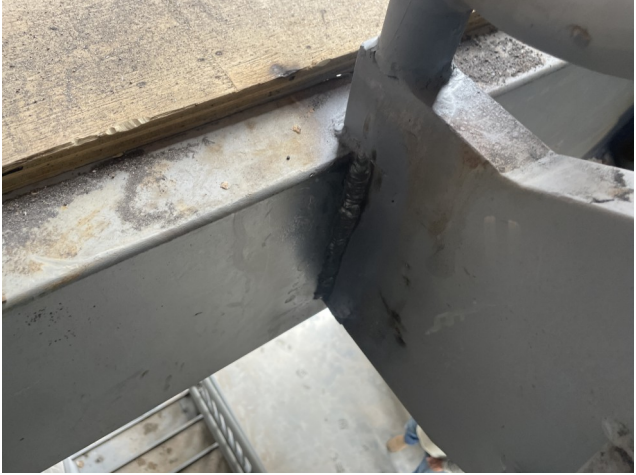
a. The stringer-to-channel landing connection is detailed as a CJP weld in Detail D/E5016; however, these connections were welded in the field using fillet welds.

| <p align="center"><b>Description</b></p> <p>The stringer-to-channel landing connection is detailed as a CJP weld in Detail D/E5016; however, these connections were welded in the field using fillet welds.</p> | | <p align="center"><b>Description</b></p> <p>The stringer-to-channel landing connection is detailed as a CJP weld in Detail D/E5016; however, these connections were welded in the field using fillet welds.</p> | |

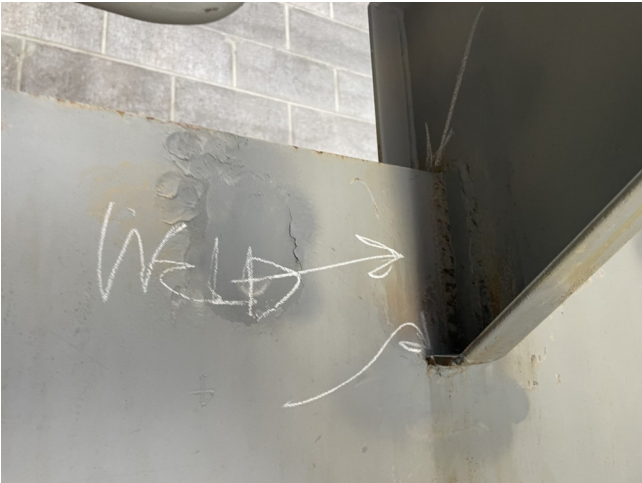
| <p align="center"><b>Description</b></p> <p>Staircase welding in need of repairs were marked with soapstone.</p> | | <p align="center"><b>Description</b></p> <p>At the staircase located at (01 to 02; G.7 to F), missing anchors are present.</p> | |

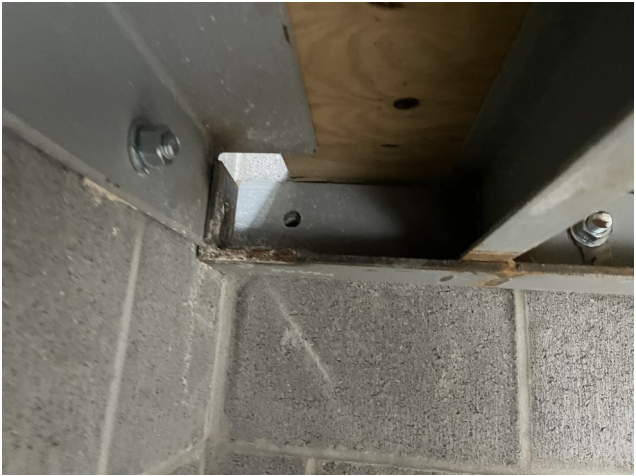
b. At the staircase located at (01 to 02; G.7 to F), missing anchors and visually discrepant welds were observed. Welds appeared to exhibit undercut and overlap.

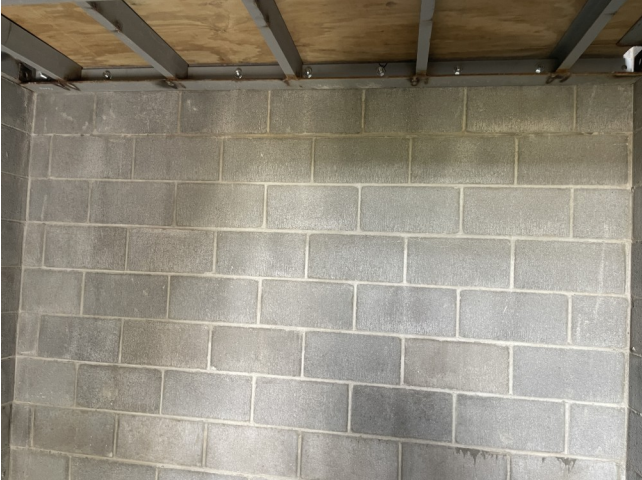
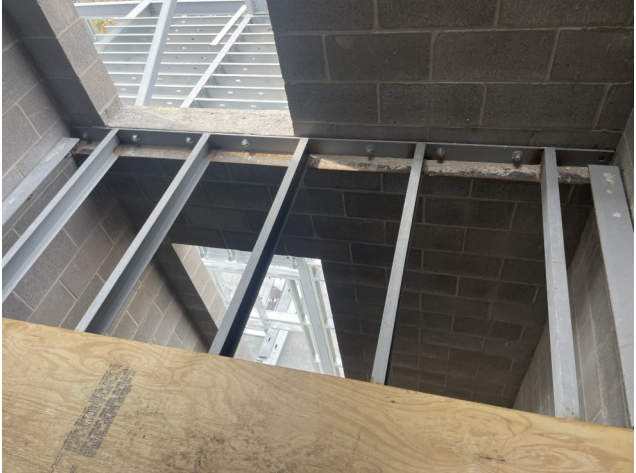
| <b>Description</b><br>At the staircase located at (01 to 02; G.7 to F), missing anchors are present. | <b>Description</b><br>At the staircase located at (01 to 02; G.7 to F), missing anchors are present. |
